## Hands on the Landmarks, Part 2

As project supervisor and lead carpenter on the restoration of Villard Hall, I recognize the enormous responsibility it takes to undertake such a restoration. Villard Hall, finished in 1886, is one

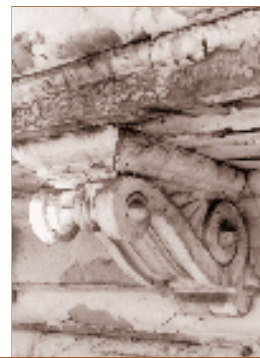
*Entablature and bracket showing paint failure, Villard Hall.*

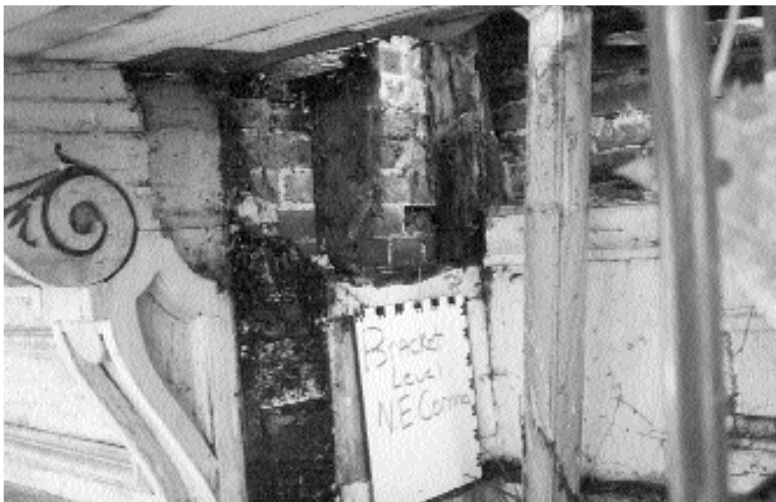
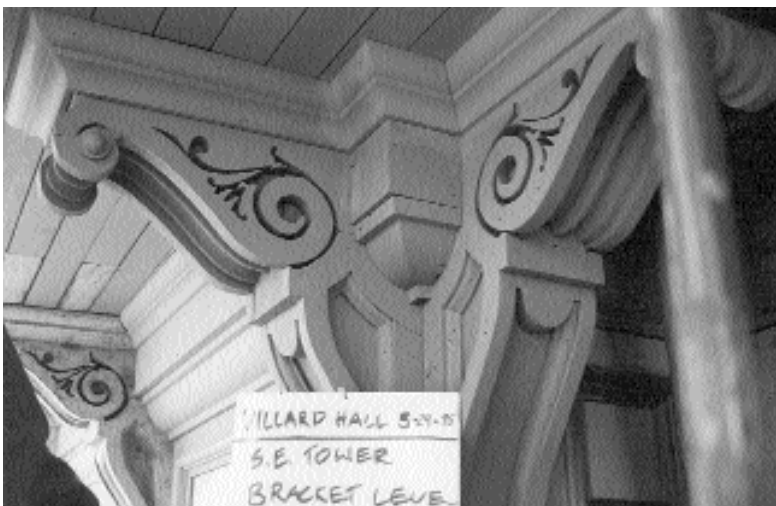
Tower bracket before restoration. Below: Same corner with new bracket trim.

Once the lead paint removal and demolition were complete, the meticulous rebuilding of the structure could begin. Like all other forms of construction, restoration is a linear process, with work completed in sequence, and the key to a successful restoration is the proper scheduling of these sequences. The rebuilding began with the entablature/lower cornice and gutters since much of the future work depended on having the gutter metal installed. The gutter is supported by both the entablature brackets, as well as 4' lookouts that run horizontally into the masonry structure. Nearly half of the lookouts were badly deteriorated and were replaced in kind with Douglas Fir. Much of the original fir tongue and groove soffit sheathing was also deteriorated and was replaced in kind with stock milled in our shop. Most of the gutter boards were in reasonable condition, and those that were not were again replaced in kind with milled tongue and groove. The deteriorated and missing brackets in the entablature were repaired and replaced in-kind with cedar and re-installed using plated deck screws instead of nails. This was done to both facilitate future removal, as well as add some seismic stability to the brackets. Before the restoration, the brackets had an occasional tendency to fall off the building.

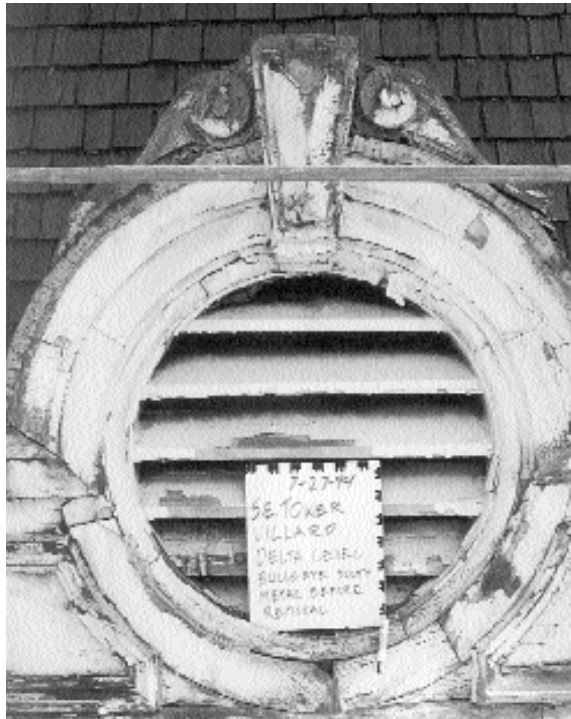
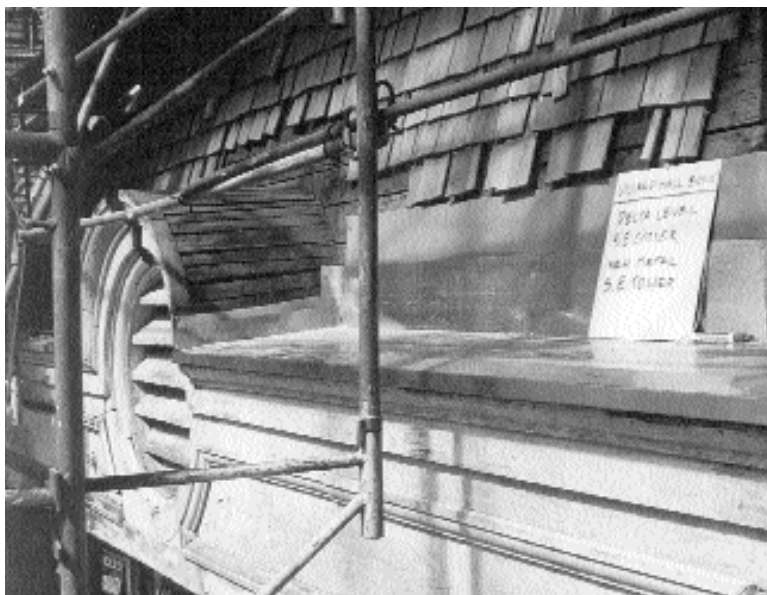
Bullseye showing lead paint failure. Below: Bullseye and parapet with new metal plate.

With the completion of the gutter, work could proceed on the parapet and the mansard roof shingling. Although the parapet is very exposed to inclement weather, deterioration was limited to the skirt boards and the ornamentation over the south and east bulls eyes. The skirt boards on the parapet were badly weathered and replaced in-kind with 1x12 clear cedar, and the keystones and flanking scrolls over the bulls eyes were also replaced in-kind with cedar. The top of the parapet was then flashed with stainless steel terne plate. The shingles used for the re-roofing matched the original cedar shingles in both width and length. Before placement on the building, the shingles were hand dipped in *WoodLife Wood Preserve*, allowed to dry for three days, and then dipped in a Fuller O'Brian alkyd primer. Great care was taken to dry the shingles before dipping, which facilitates paint adhesion. The shingles were then hung on the building, duplicating the original courses, which had been marked as the old shingles were pulled off.

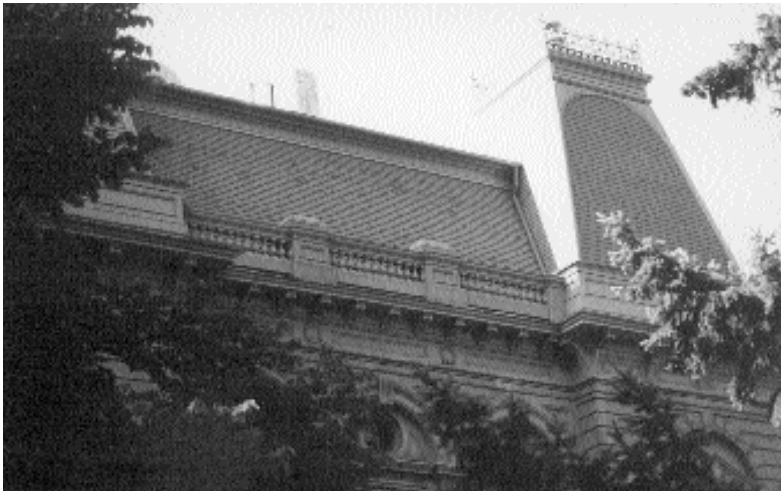
Restored north  
facade of Villard  
Hall.
